Technical Report CHL-97-32
November 1997

Periodic Inspection of Ofu Harbor Breakwater, American Samoa

Report 1 Base Conditions

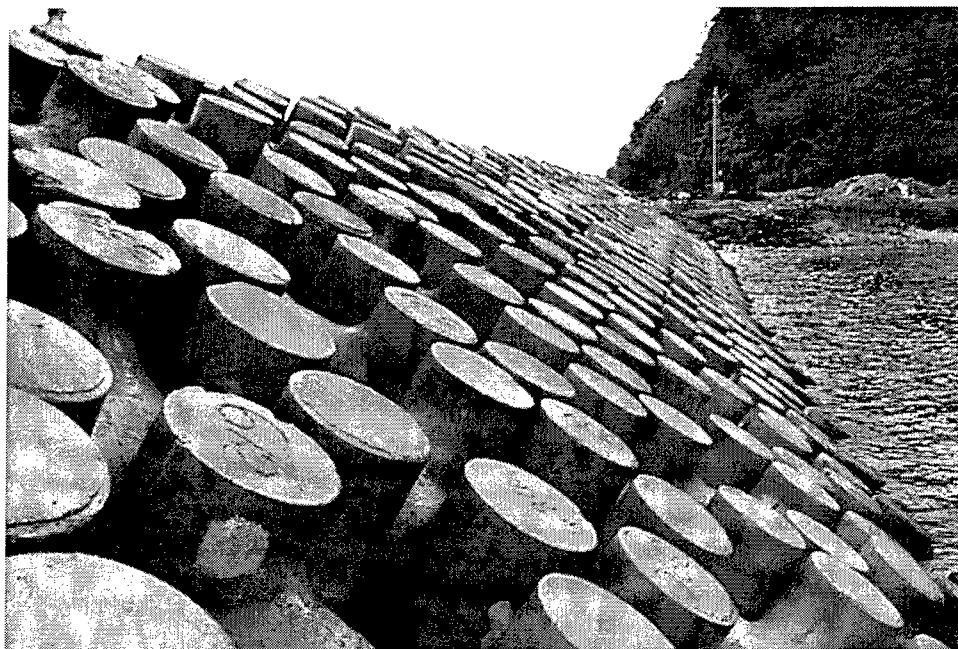
The breakwater armor consisted of a single layer of uniformly placed 4,080-kg (4.5-ton) concrete tribar units (Figure 5). The tribars originated at sta 1+75 on the seaward face of the structure and extended to sta 6+00, around the head, and then to sta 4+00 on the harbor side of the breakwater. To improve the stability of the tribars, work included the construction of a toe trench in order to stabilize the armor unit toe, and a concrete rib cap system on the breakwater crest to stabilize and buttress tribars at the upper sea-side and harbor-side slopes. The rib cap forms were fabricated and concrete poured right into the top section of the tribars (Figure 6). The crest elevation of the rib cap was +4.6 m (+15 ft), and the slope of the structure was 1V:1.5H.

Figure 5. Tribar armor units used on Ofu Harbor breakwater

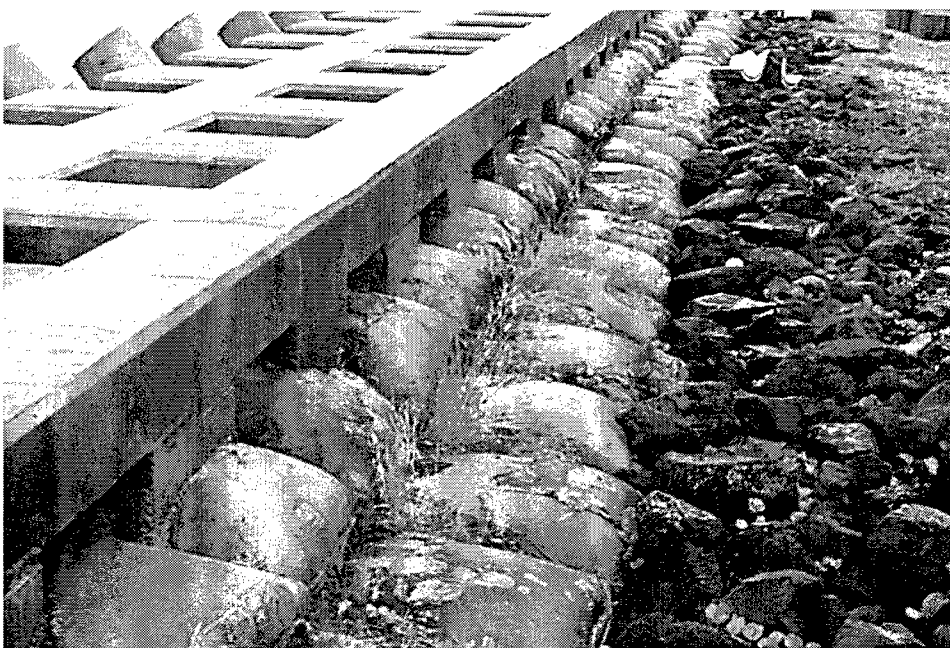
In addition to the "swiss cheese block" underlayer unit, both 2,270-kg and 510-kg (2.5-ton and 1,125-lb) concrete units were formed by pumping high-strength, fine-aggregate concrete into geotextile fabric bags. The 2,270-kg (2.5-ton) units were used as a rib cap underlayer and were placed along the landfill on the harbor side of the structure between stas 1+75 and 4+00 (Figure 8). These units measured approximately $1.4 \times 0.9 \times 0.8$ m ($4.5 \times 3.0 \times 2.5$ ft) in size.

Figure 8. 2,270-kg (2.5-ton) high-strength concrete units used on harbor side of structure

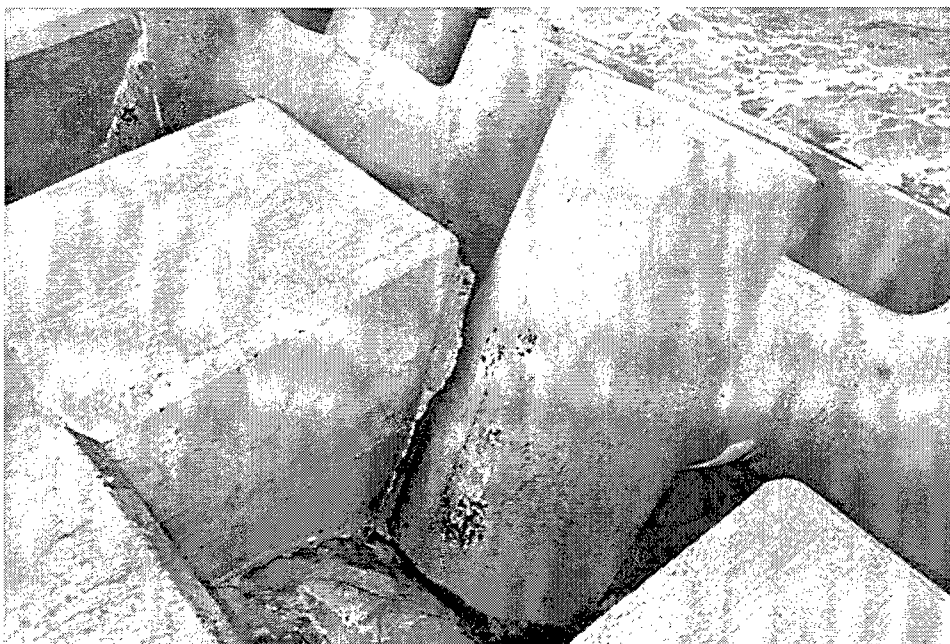
On 16 October 1996, a walking survey of armor units above the waterline was conducted on the outer 130-m (425-ft) portion of the Ofu Harbor breakwater. The survey of the structure revealed no broken tribars. One sea-side tribar was slightly separated from the rib cap (Figure 11) at sta 3+05. On the

Figure 11. Separation between tribar and rib cap

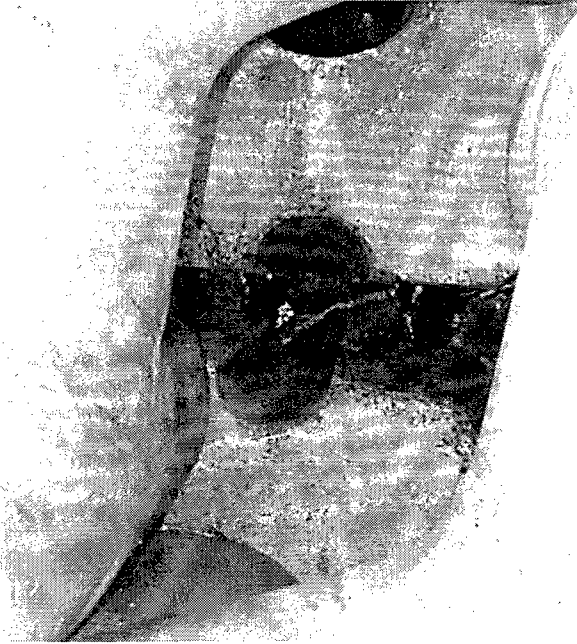
sea side of the structure it also was noted that some of the “swiss cheese block” underlayer units had separated along the slope (approximately sta 4+50). One separation was about 20 cm (8 in.) as shown in Figure 12, with a few others about 10 cm (4 in.). It appeared that the separations were caused due to the lower underlayer units subsiding on their bottom ends. The geotextile bags had deteriorated and some spalling along the edges of the 510-kg (1,125-lb) high-strength concrete underlayer units was also noted around the head of the structure (Figure 13). In general, the breakwater appeared to be in excellent condition.

Figure 12. Separation between “swiss cheese block” underlayer units

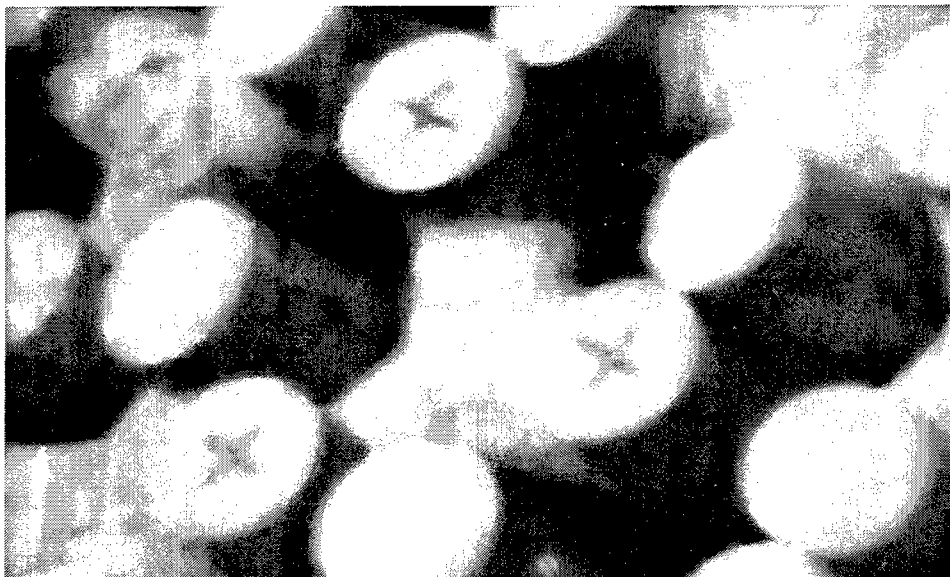
A total of 33 tribars were selected for detailed study. They represent an even distribution throughout the tribar field, and occupy positions ranging from near the waterline to close to the rib cap at the crest of the structure. These armor units (tribars 101-133) were painted with three targets (Figure 15). The target number is followed by an A, B, or C. Three targets on an individual tribar allow for very precise measurements depicting individual armor unit movement. Twenty additional tribars (units 19-38) were painted with a single target to serve as photogrammetric control points, as well as to be used to detect armor unit movement during future ground surveys. A 0.64-cm (1/4-in.) hole was drilled at the center of each target to mark the survey points for subsequent surveys. Locations of the targeted tribars are shown in Figures 16 and 17. Positions and elevations of the targeted tribars obtained during the October 1996 survey are presented in Table 1.

Figure 15. View of a targeted tribar (three targets established)
